TBF/TBM Avenger

Walk Around Number 25
squadron/signal publications

By Lou Drendel

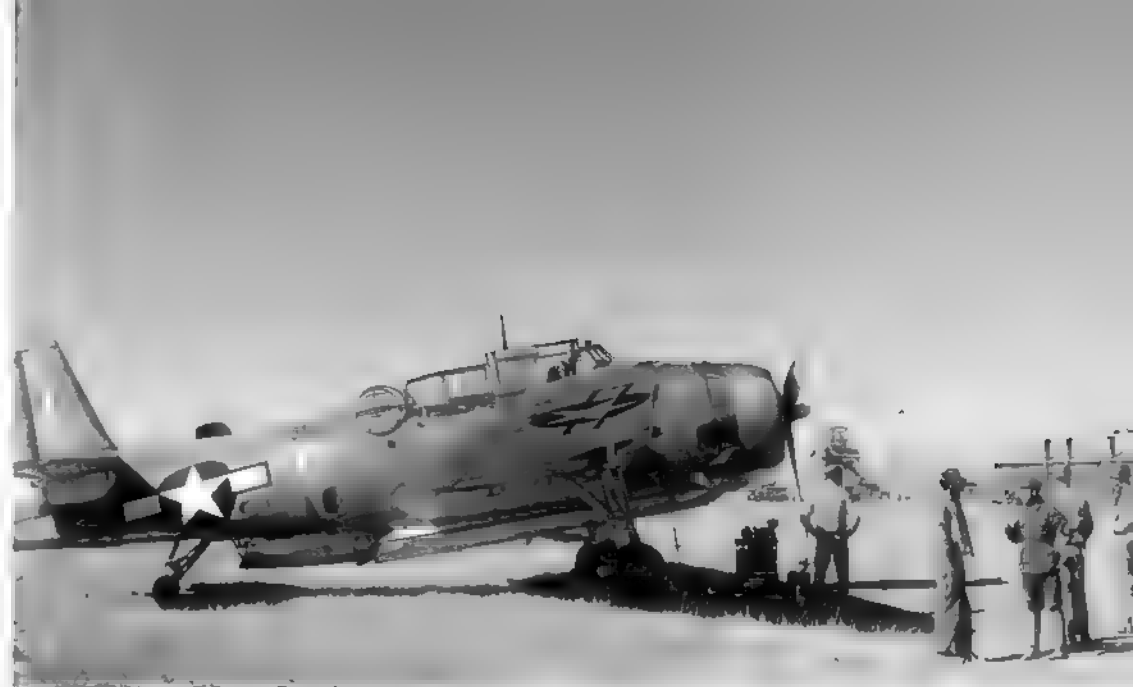
White 1, a TBM-3 of Marine Air Group 24 (MAG-24), was used for daily mail flights between Marine garrisons in Peiping (now Beijing) and Tientsin (now Tianjin), China. It was preparing to takeoff from Nan Yuan Field in Peiping in late 1945. A Marine sergeant (second from left) was conversing with a Chinese officer visiting the airfield. The Avenger's large bomb bay made the aircraft useful in the utility transport role after World War II. (Norman E. Taylor Collection)

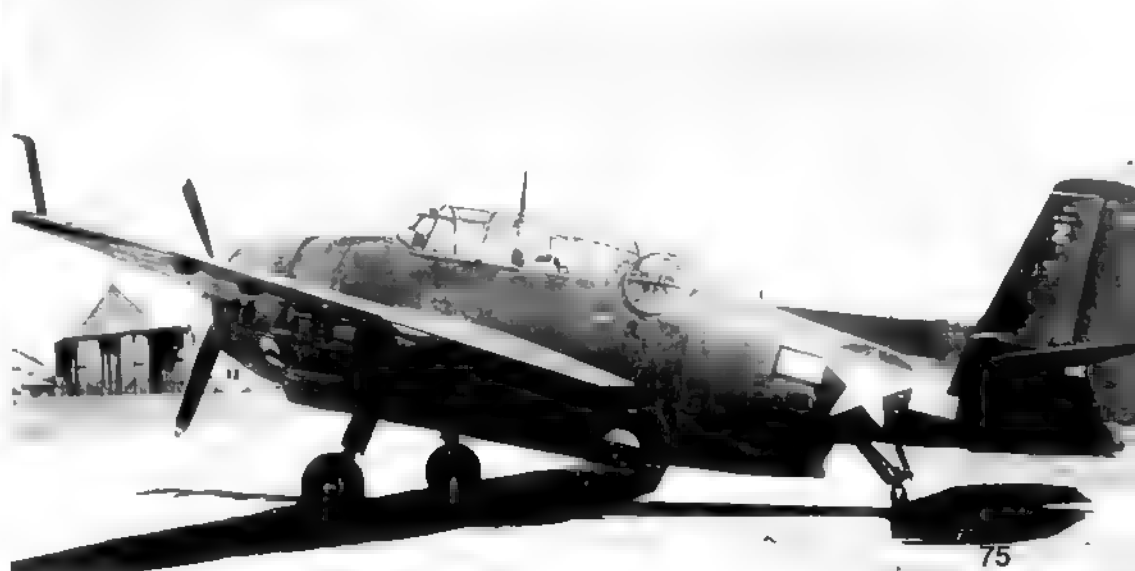
Eastern Aircraft TBM-1C, Black 2, was assigned to Composite Squadron 12 (VC-12) aboard the USS CHARGER (CVE-30) in the North Atlantic during the fall of 1944. The Avenger was camouflaged in the Atlantic Anti-Submarine Scheme II, which consisted of Dark Gull Gray (FS36231) uppersurfaces with Non-Specular White (FS37855) sides and undersurfaces. This superseded the Atlantic Anti-Submarine Scheme I of Dark Gull Gray, Light Gull Gray (FS36440), and White.

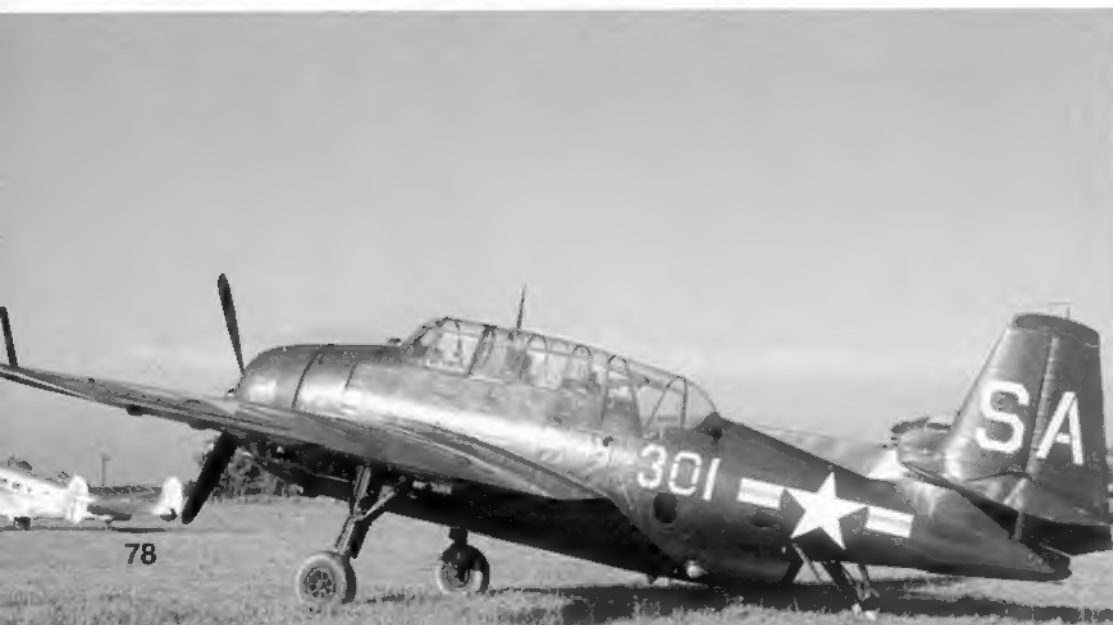
A TBM-3S (SA-301) was displayed at the Cleveland National Air Races in August of 1947. The -3S version was a TBM-3E modified for the ASW 'killer' mission. A radar operator rode in the aft cockpit space formerly occupied by the turret gunner. Mark 5 rocket launchers were retained under the wings; however, all machine guns were removed from the TBM-3S. (Warren Bodie via Norman E. Taylor collection)

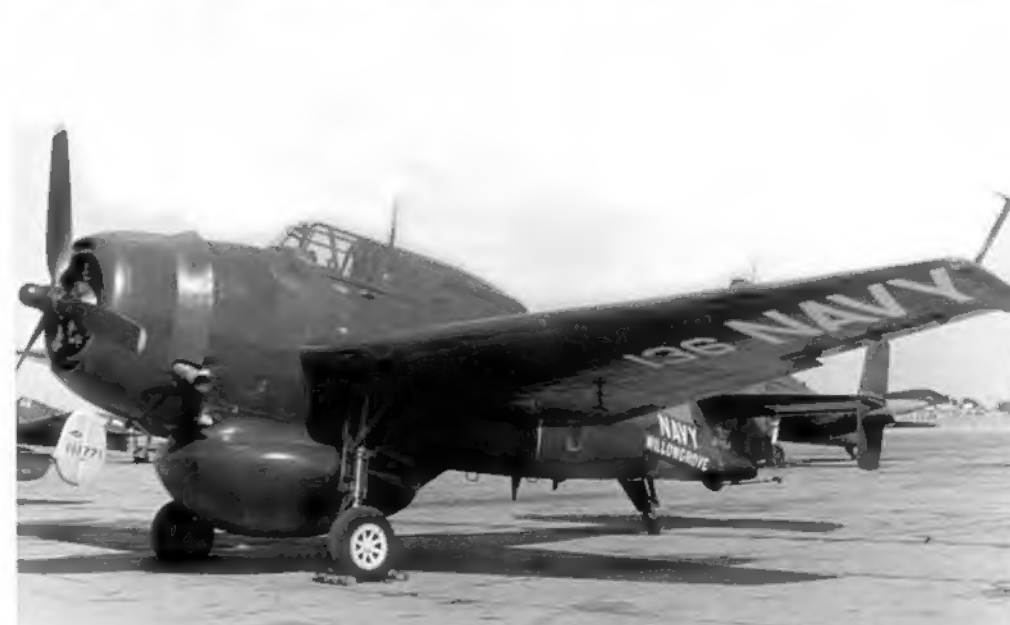
This TBM-3W2 (BuNo 91454) was parked at Love Field, Dallas, Texas on 5 August 1954. The Avenger was assigned to a Naval Reserve unit at NAS (Naval Air Station) Willow Grove, Pennsylvania, as indicated by the International Orange (FS12197) aft fuselage band. The undersurface radome housed the AN/APS-20 radar antenna. This radar was optimized for detecting submarine snorkels and had an effective range of 135 nautical miles (250.2 km). (Norman E. Taylor collection.)

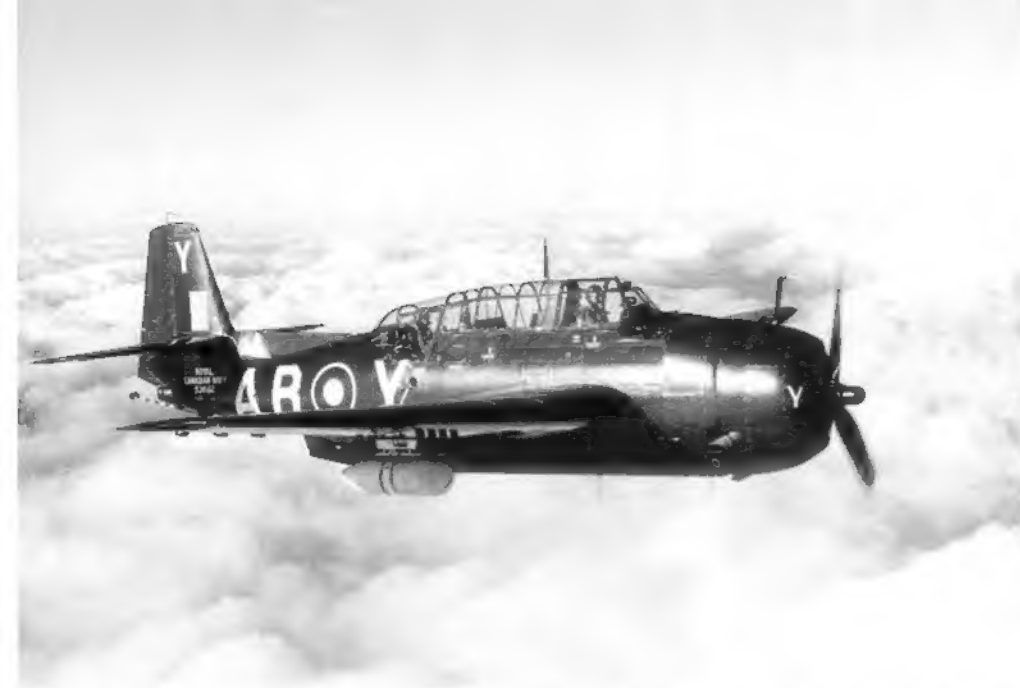
This TBM-3S (AR-Y, 53682) was assigned to No. 880 Squadron of the Royal Canadian Navy (RCN). The pod under the starboard wing housed an AN/APS-4 search radar, which supported the aircraft's role as a 'killer' in anti-submarine 'hunter-killer' teams with TBM-3Ws. Canada received 125 Avengers from the US Navy in 1950-52, which were designated Avenger AS Mark 3s by the RCN. They remained in front line Canadian service until 1957. (Warren Bodie)

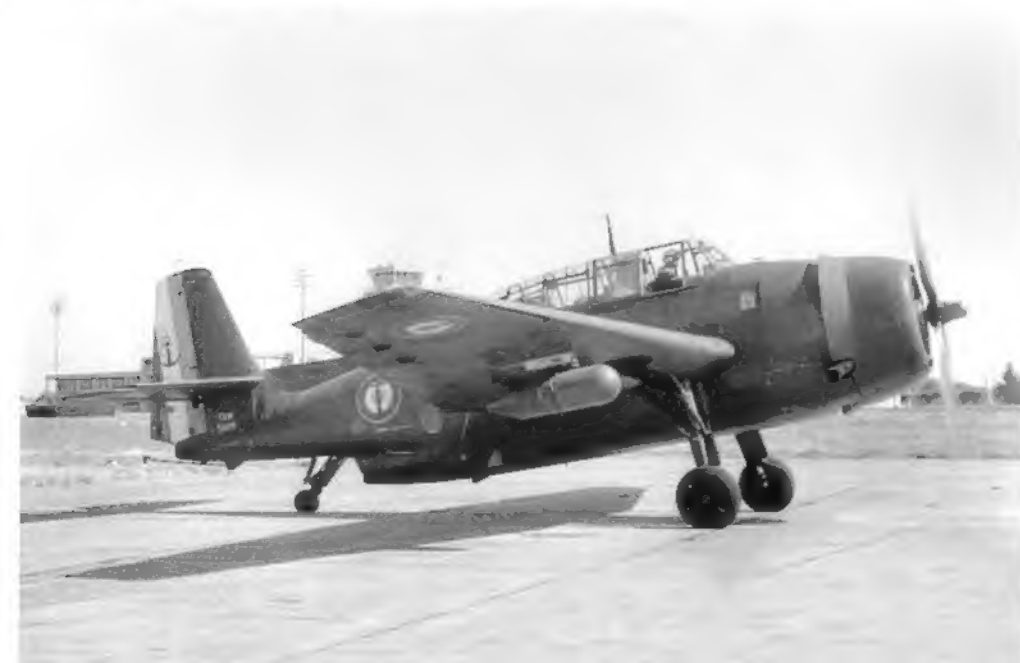
This overall Glossy Sea Blue TBM-3S (53678) was assigned to *Escadrille* (Second-Line Squadron) 3S of the French *Aéronautique Navale* at Cuers, France in 1965. The Squadron's insignia appeared on the forward fuselage, ahead of the canopy area. France acquired 140 Avengers from the US under the MDAP between 1951 and 1958. These aircraft operated in the anti-submarine role from the French carriers *ARROMANCHES*, *BOIS BELLEAU*, and *LAFAYETTE*. (Norman E. Taylor collection)
